Service Bulletin

Bulletin No.: PIP5096A

Subject: DTC P0024 Light With No Drivability Concerns

Models: 2012-2014 Buick Lacrosse
2012-2014 Cadillac SRX
2012-2014 Chevrolet Captiva Sport
2012-2014 Chevrolet Impala Classic
with 3.0L LFW and 3.6L LFX engines

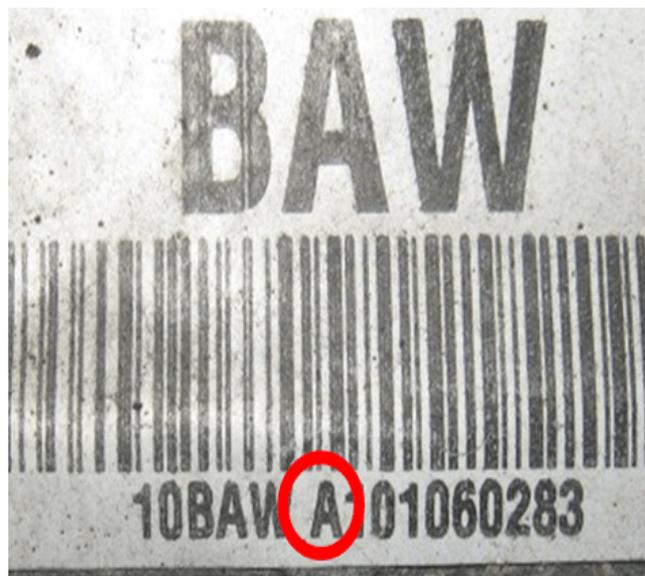
3291987

If you get a vehicle with this code, and no other drivability concerns, inspect the engine EUN sticker for an A before the sequence number; before replacing the actuator.

The engine EUN sticker should be located on the engine left side below the left head or on the back of the left head. (See the example below)

If there is an "A" before the sequence number then replace the OCV/Cam Actuator Solenoid Valve with a replacement "service" valve.

The service OCV is from a different supplier and can make up the difference in the clearance that causes this concern.
